Plane and Pilot just fell out of the Sky

PT-17 Stearman

By David Trojan, davidtrojan@earthlink.net

March 2011

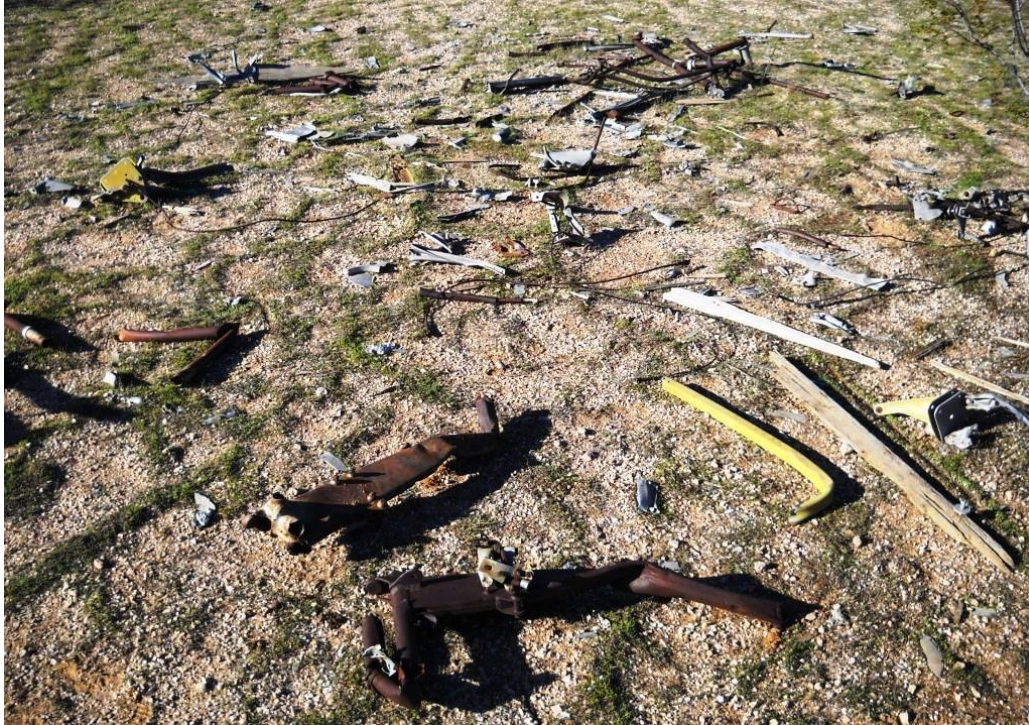
Scattered debris at crash site

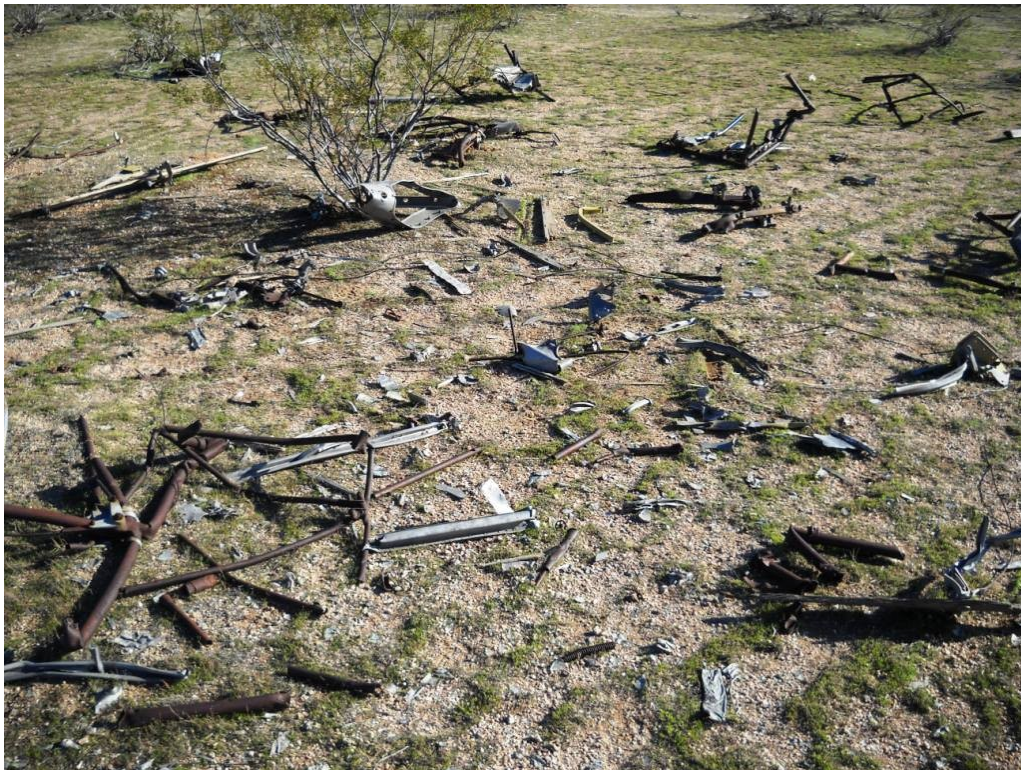
More scattered debris

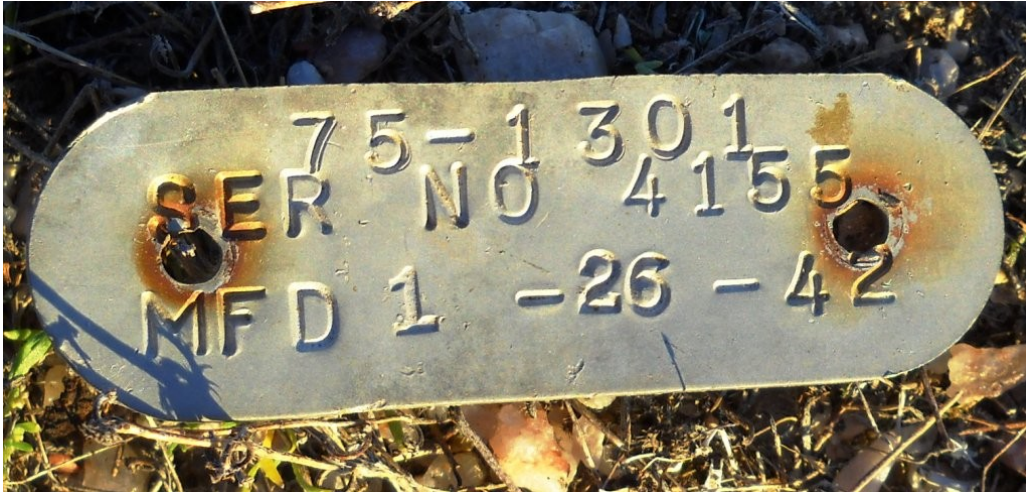
Tag with date of manufacture, serial number and part number that corresponds to the Frame Assembly, Center Section according to the parts manual.
The aircraft was manufactured on January 26, 1942.

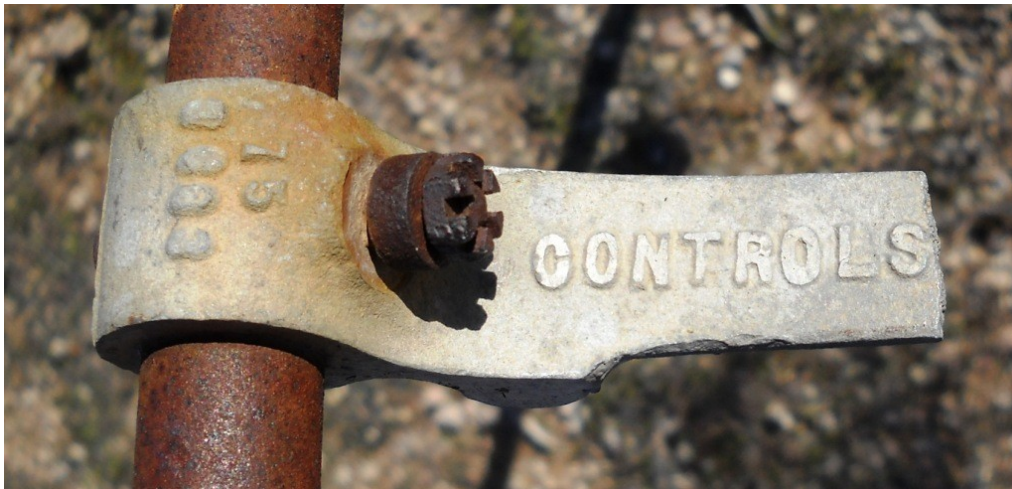
Part labeled controls

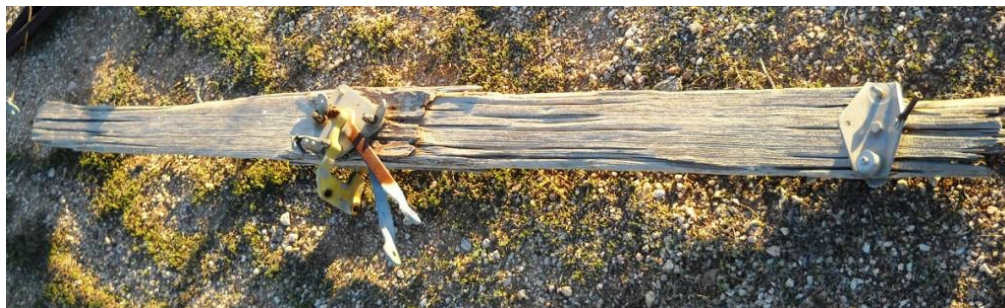
Wood wing spar

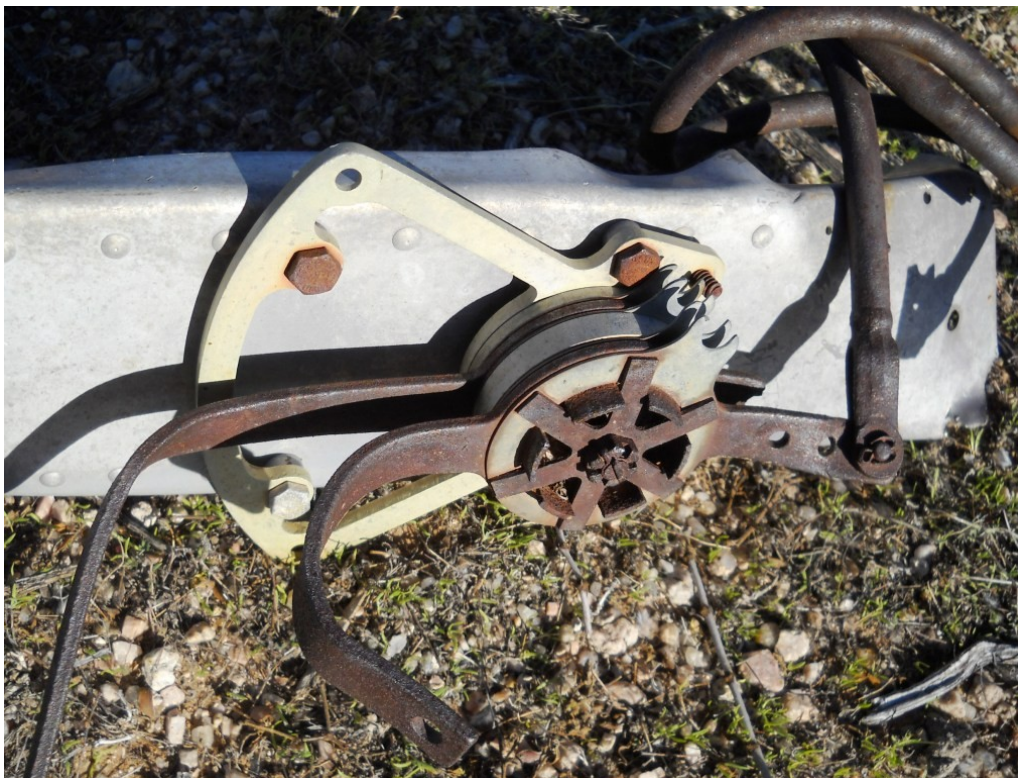
I explored the crash site in January 2011 using location information from the previous investigator. My goal was to document this incident in historical context rather than record just how it crashed according to official records. The crash site now lies near development and construction activities and is vulnerable to disturbance or destruction. I wanted to document the site before it is gone because sites like this are very rare. The debris in the desert may look like just another junk pile, but to the trained aviation archaeologist eye, aircraft parts were readily identifiable and revealed important clues to the story behind the crash. Parts of the Stearman's twisted tube metal frame and incredibly parts of the main wing wood spar still remained. Scattered in the debris were rudder pedals, control cables, seats and the aluminum tail wheel well. Bits of broken glass and slag piles of melted aluminum bear witness to the fire after the crash. Parts were found with blue and yellow paint and many parts had part numbers starting with the number 75 for the Boeing Model 75 aircraft. The throttle controls were still at the crash site jammed in the full forward position just as cadet Pilot Frank A. Atkins had left them according to the official report.

Throttle controls frozen in time in the forward position

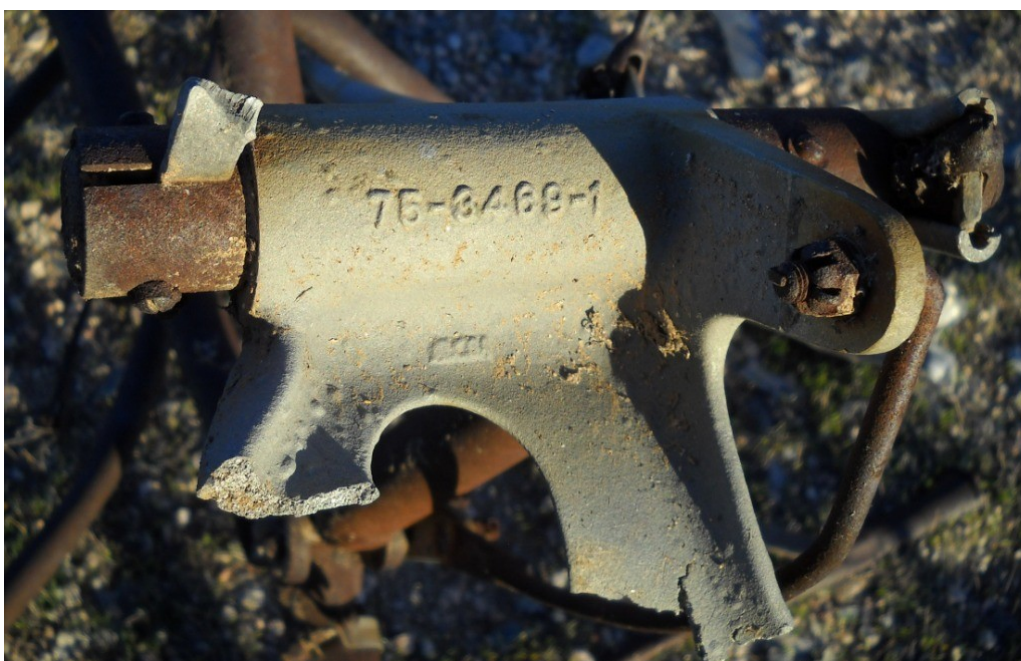
Rudder pedal with part number

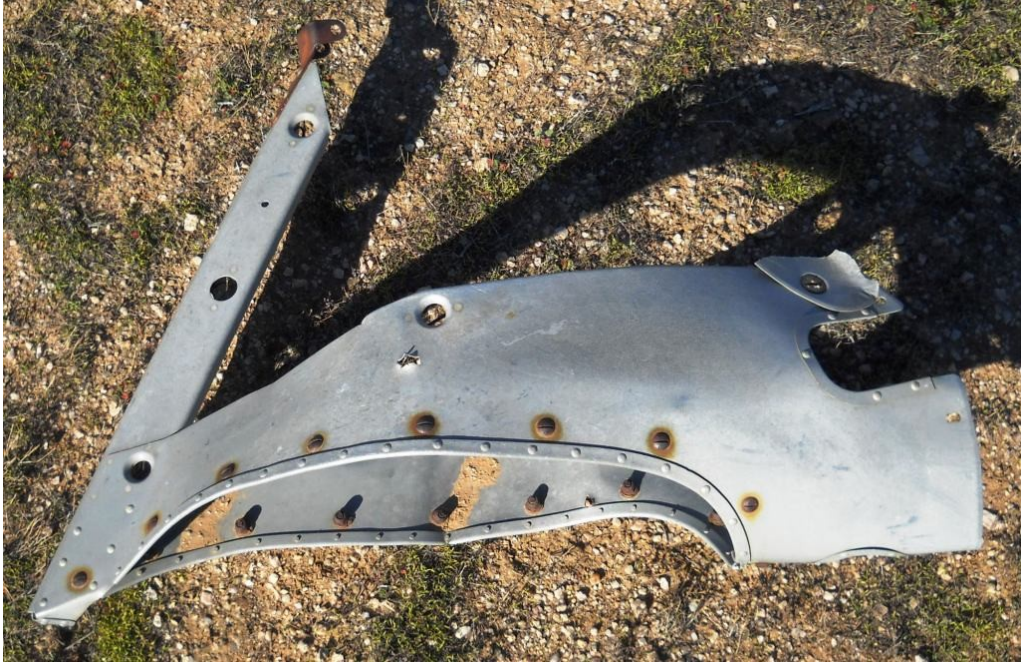
Tail wheel well

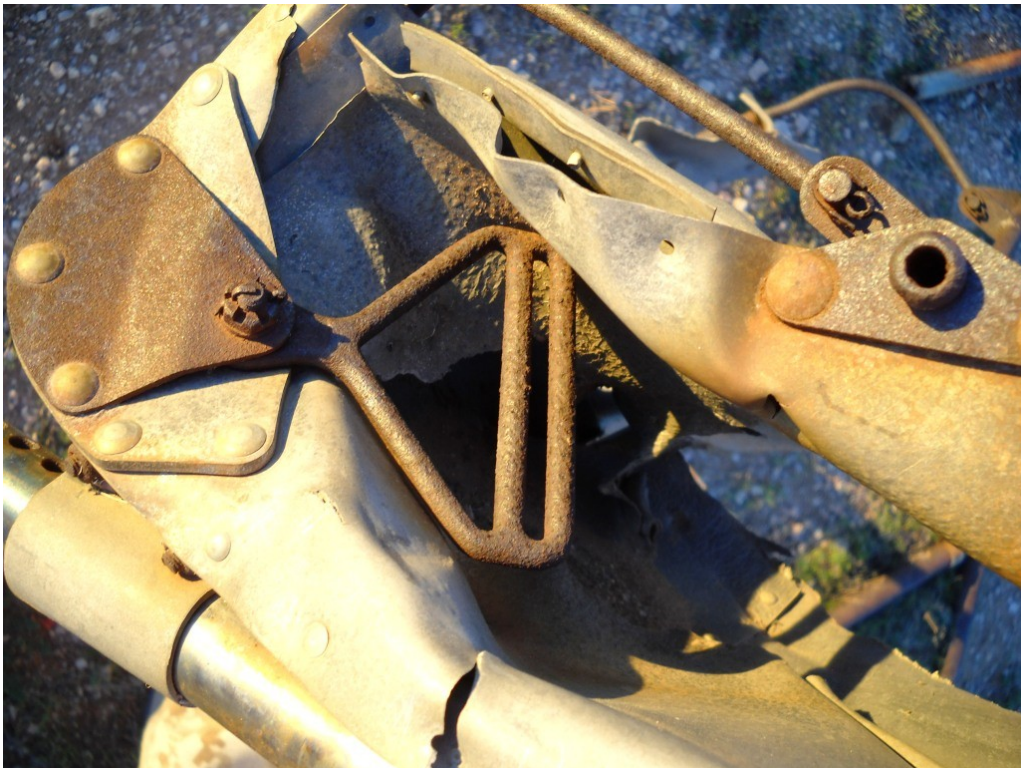
Seat harness attachment
