Martin B-26 "Marauder" #40-1520

January 14, 1942

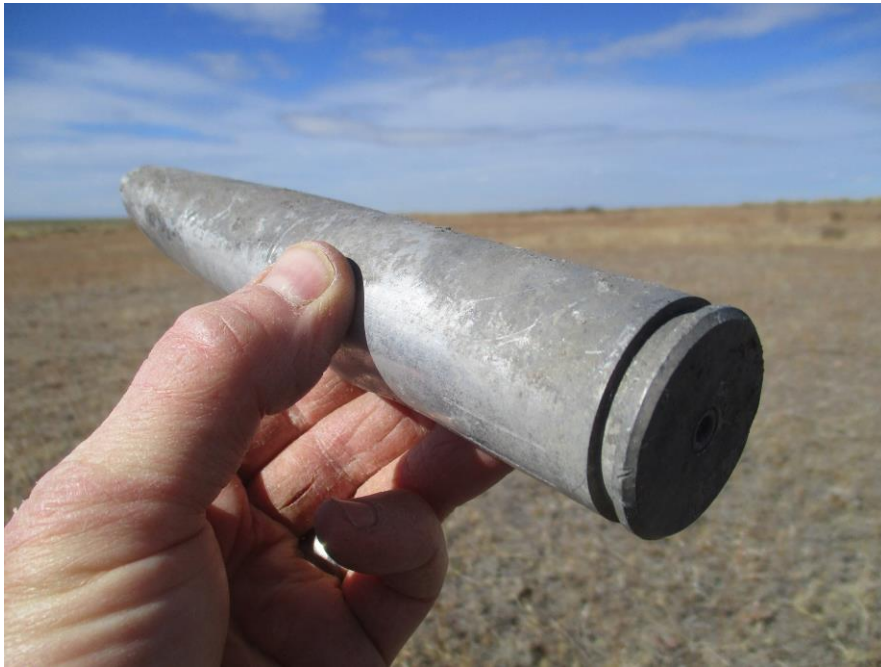
Spent flare gun cartridge

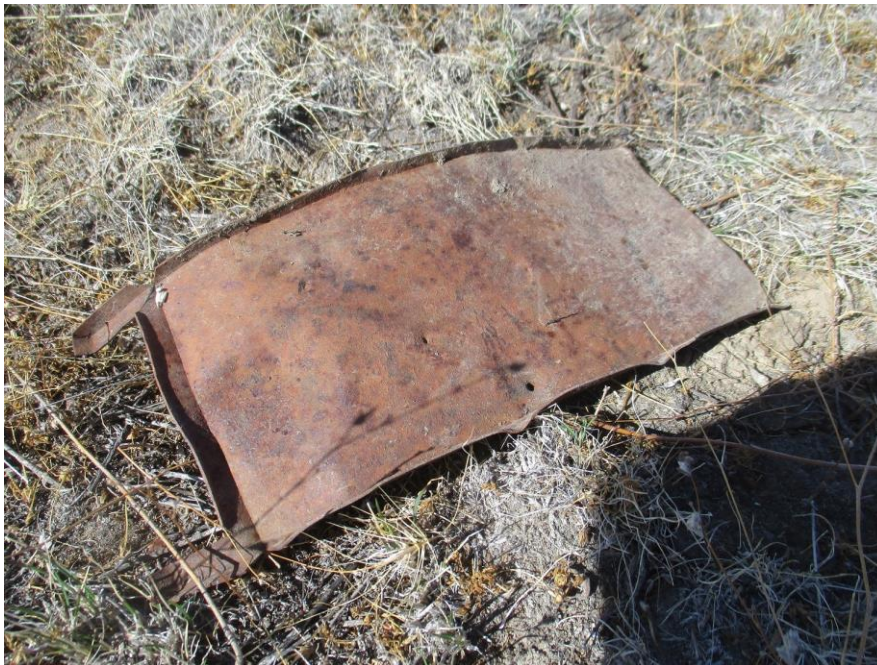
Lid from an ammunition box

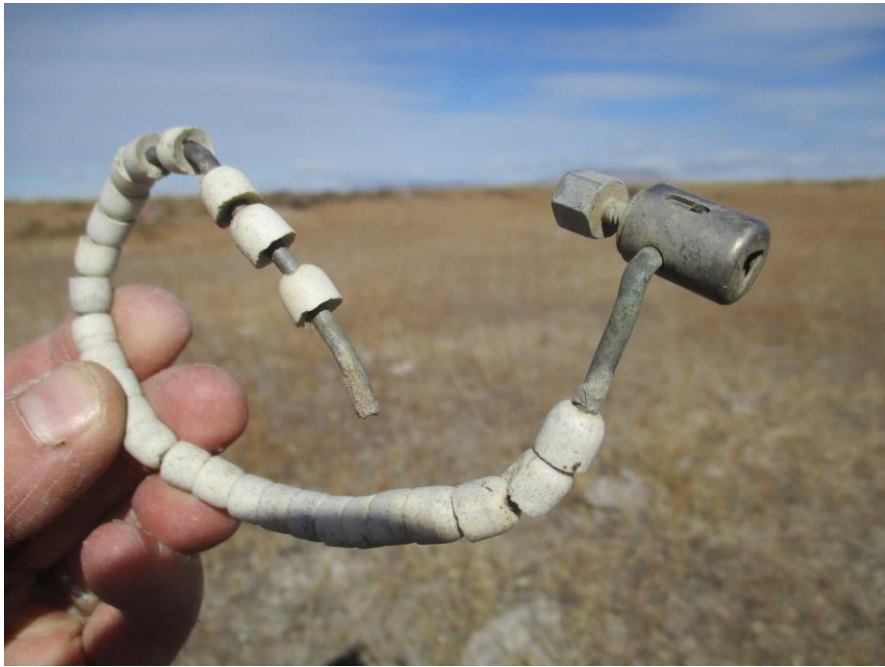
Curious-looking stainless steel wire with ceramic insulators

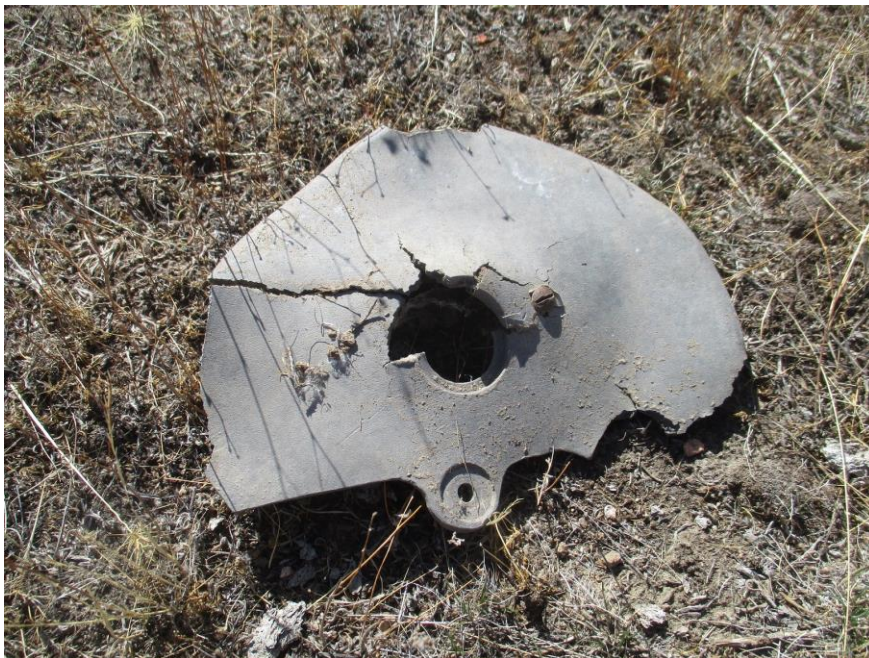
Piece of cast aluminum

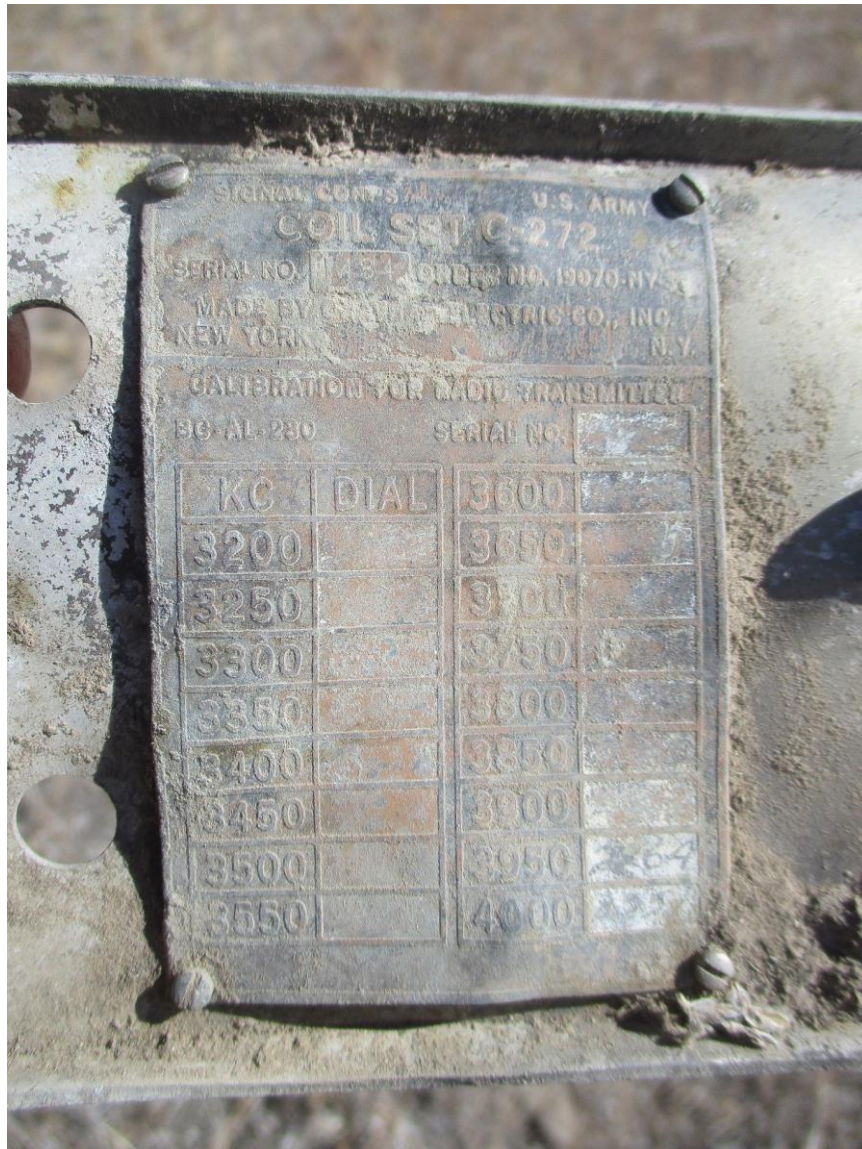
Data plate on a radio panel

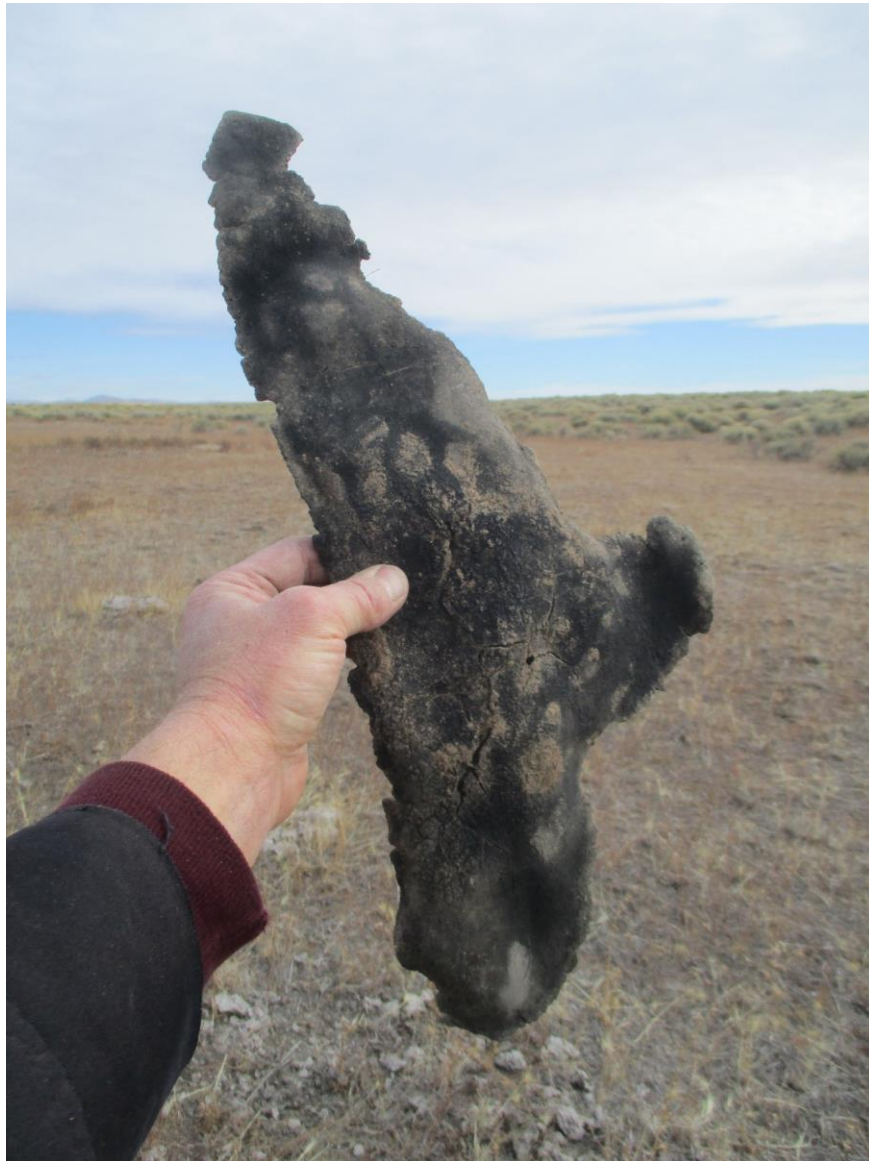
Rubber from a self-sealing fuel tank

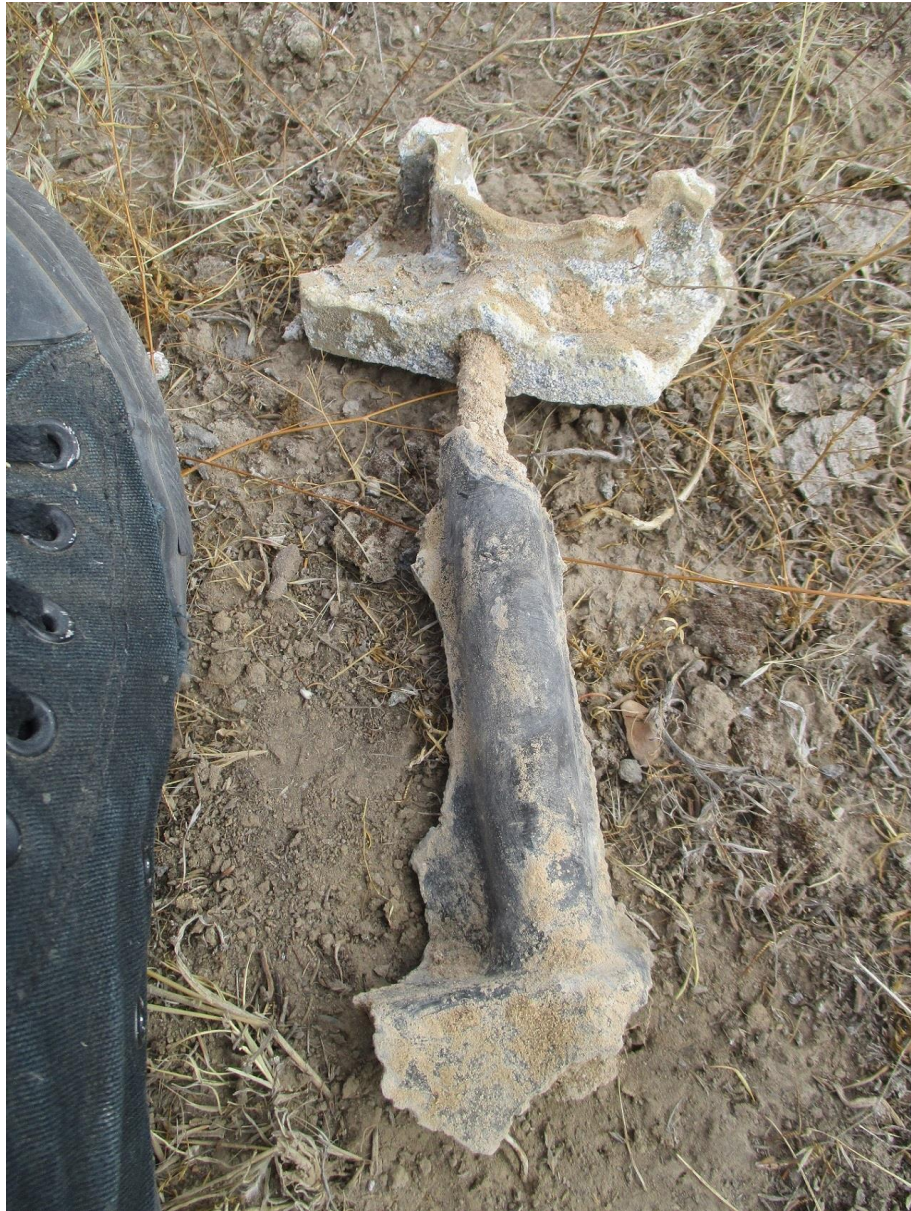
Heavy duty steel and aluminum piece, possibly from landing gear

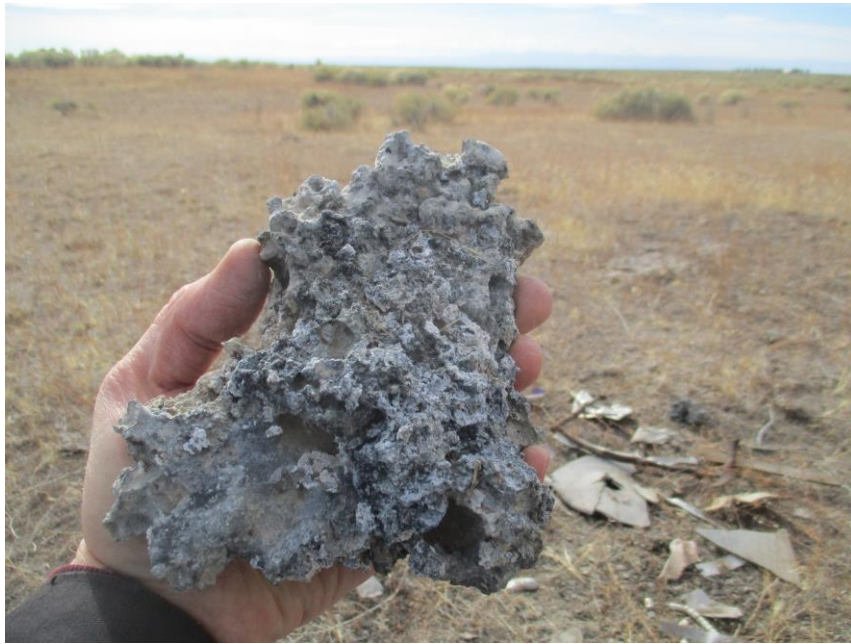
Badly burned aluminum engine part

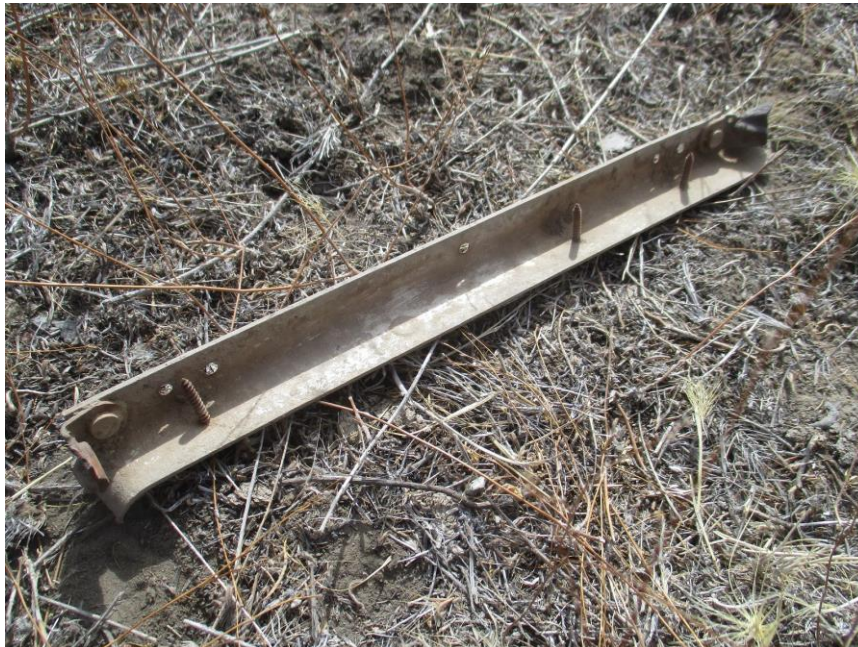
Aluminum stringer from the aircraft's framework

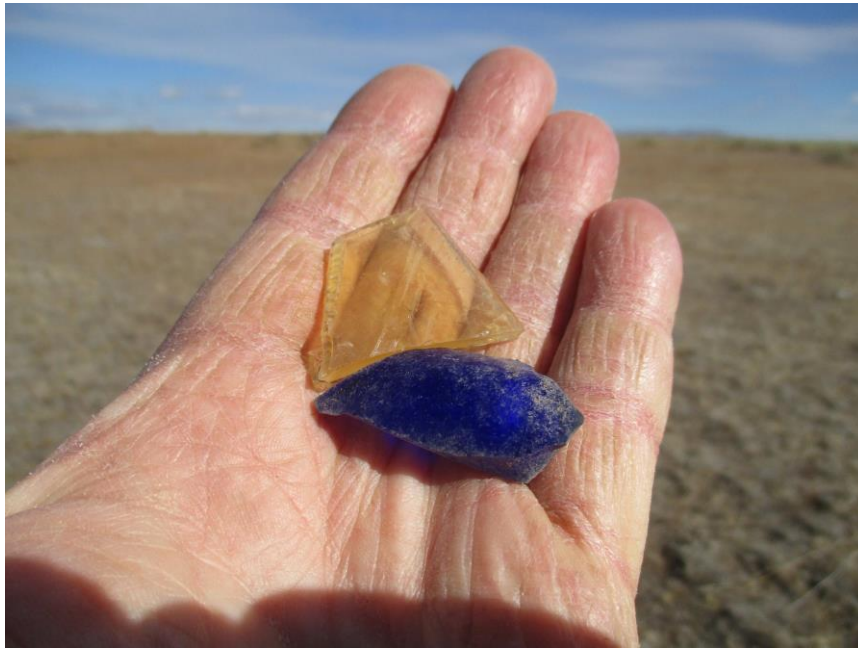
Colored glass

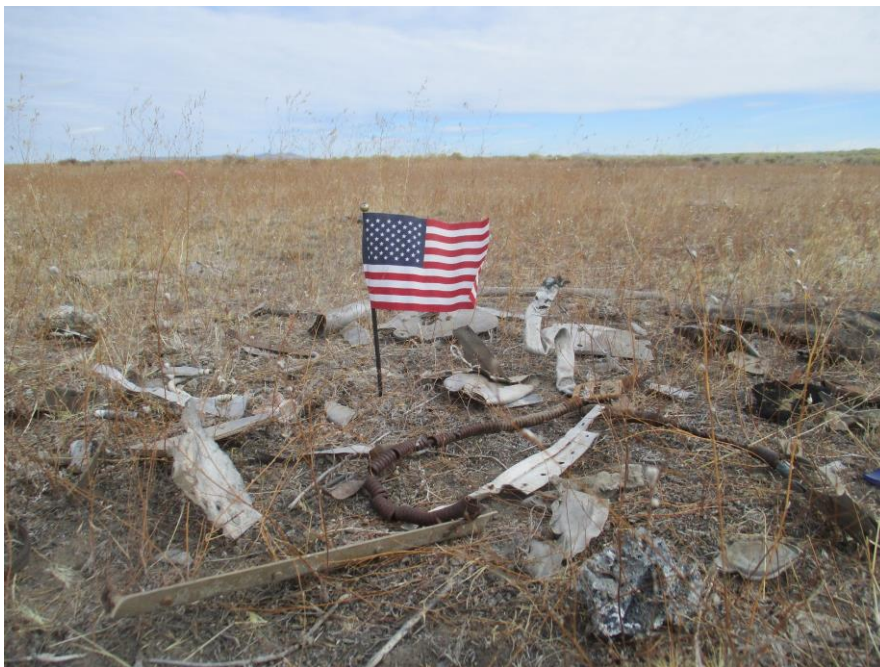
General view of the crash site
