Mid-air collision over the Mojave

Two Bell P-59A Airacomet jets collide over the desert

By David Trojan, davidtrojan@earthlink.net

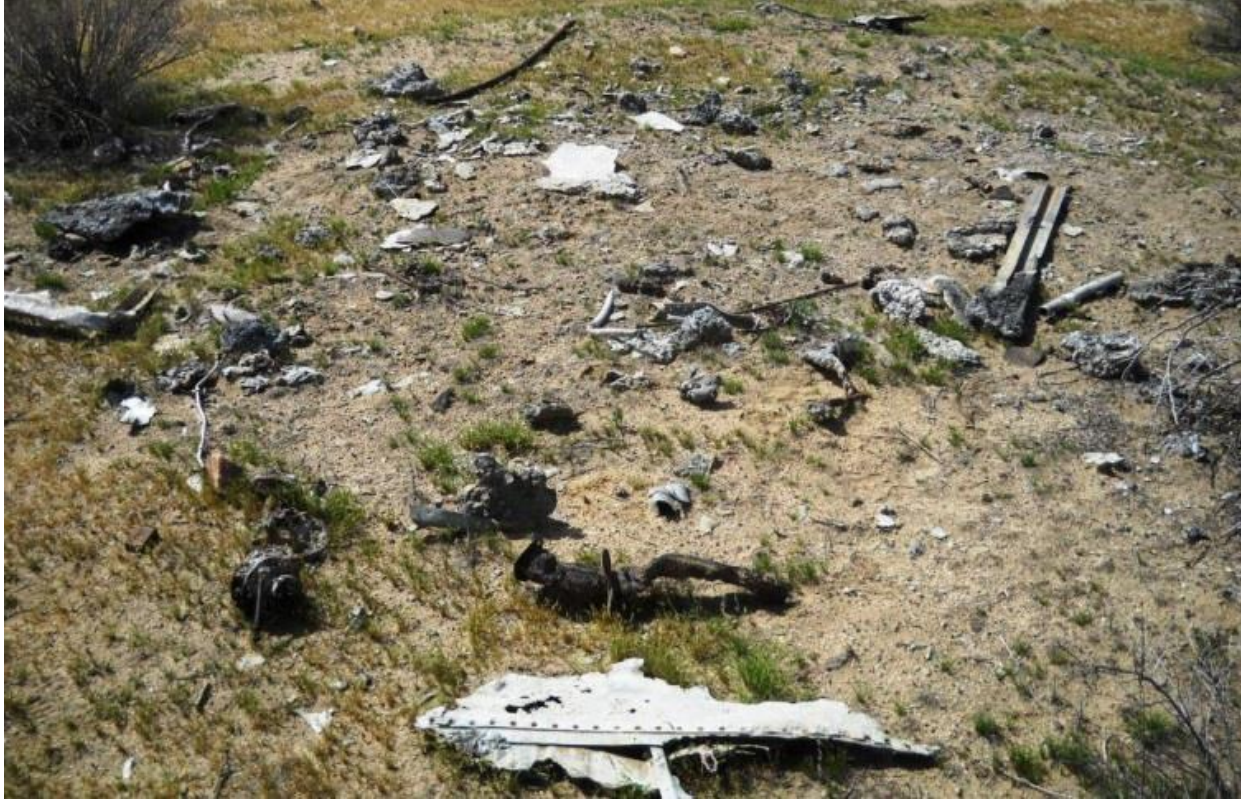
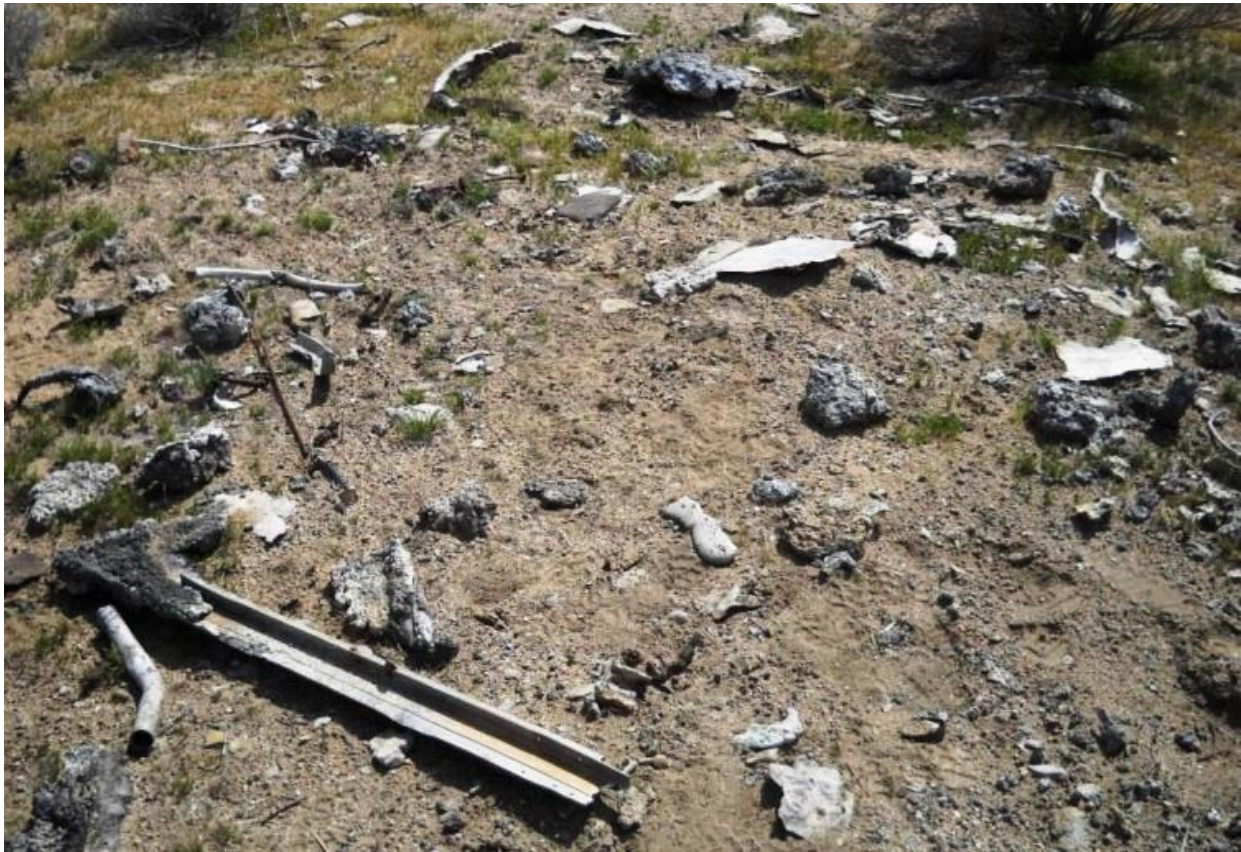
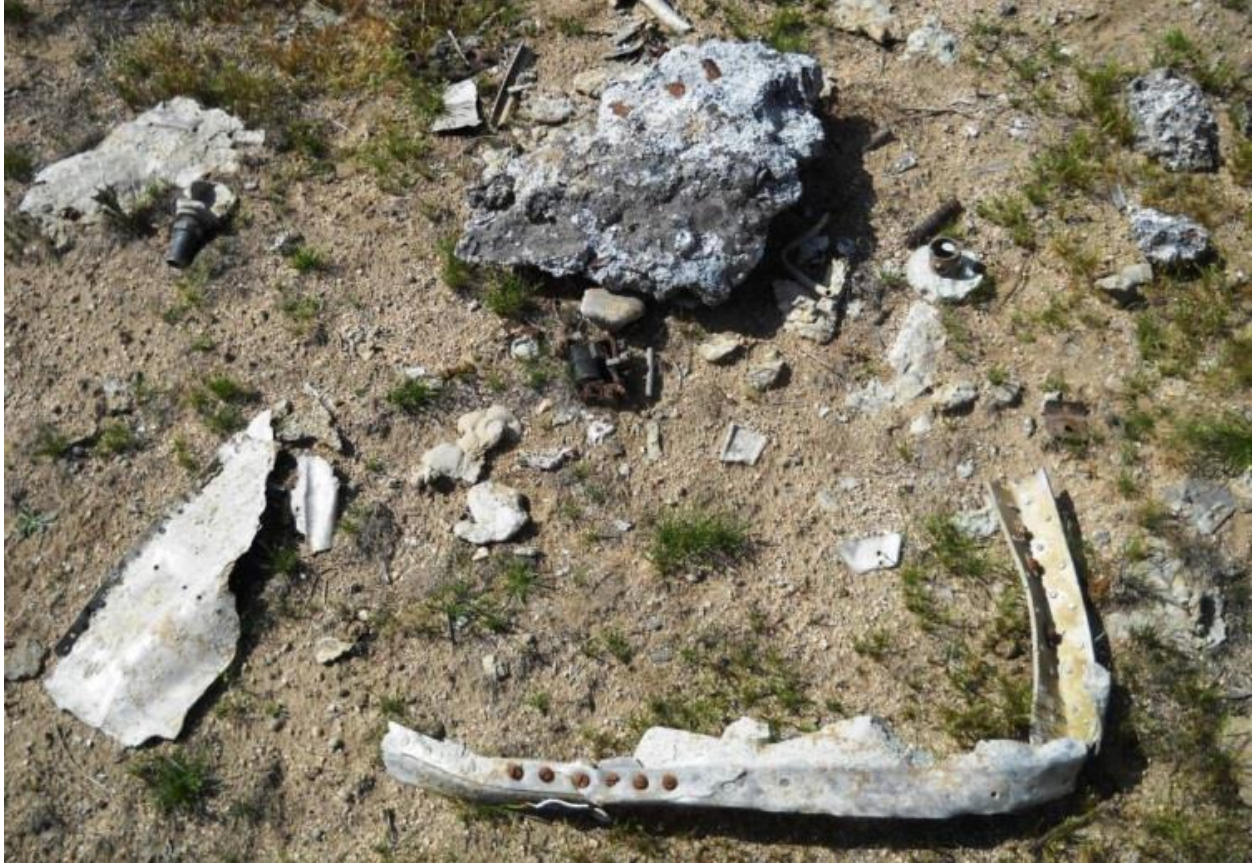
The Mojave Desert still contains the scattered remains of two of America's first jet aircraft. The area where the crash site is located is very dusty from all the dust and dirt that is thrown up by a nearby dirt road. While searching the area, I could hear the hum of the high power electric towers that still stand adjacent the crash site and played an important part in the drama. At one of the impact points, not very much remained of the P-59A Airacomet. It is marked by an ugly grey area against the green- brown colored desert. Chunks of melted aluminum slag are strewn about as a testament to the burned aircraft.

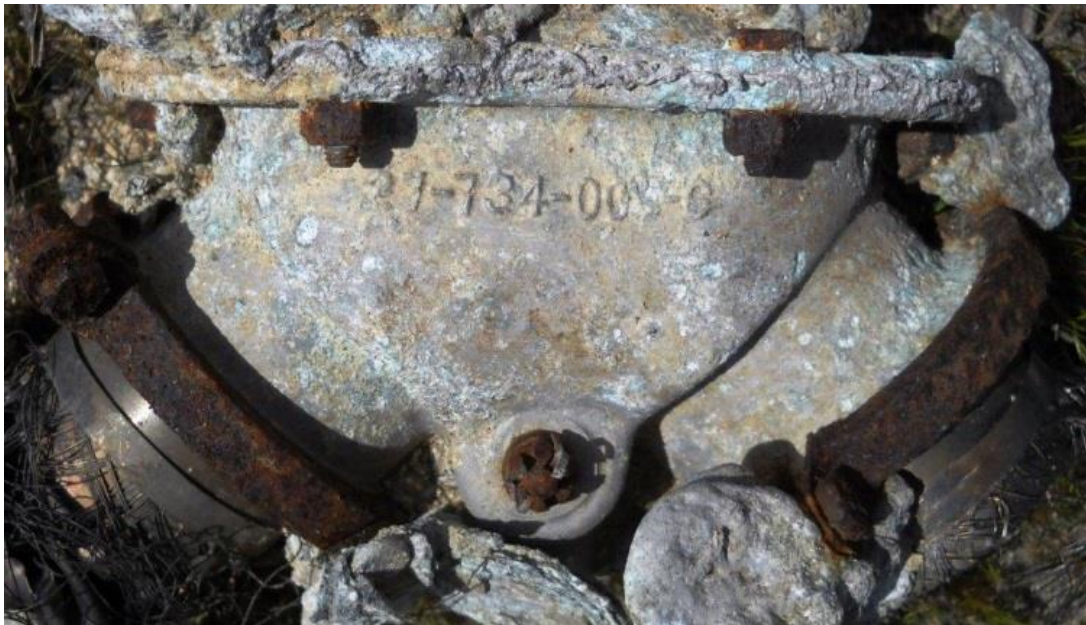
I did discover a part with the correct manufacturer part number prefix of 27- at the site to confirm that I had found a P-59 Airacomet crash site. A few parts, rivet types and sheet metal also helped to identify the type. I could perceive from the parts the similarity with other Bell aircraft types of the time period such as the P-39 Airacobra.

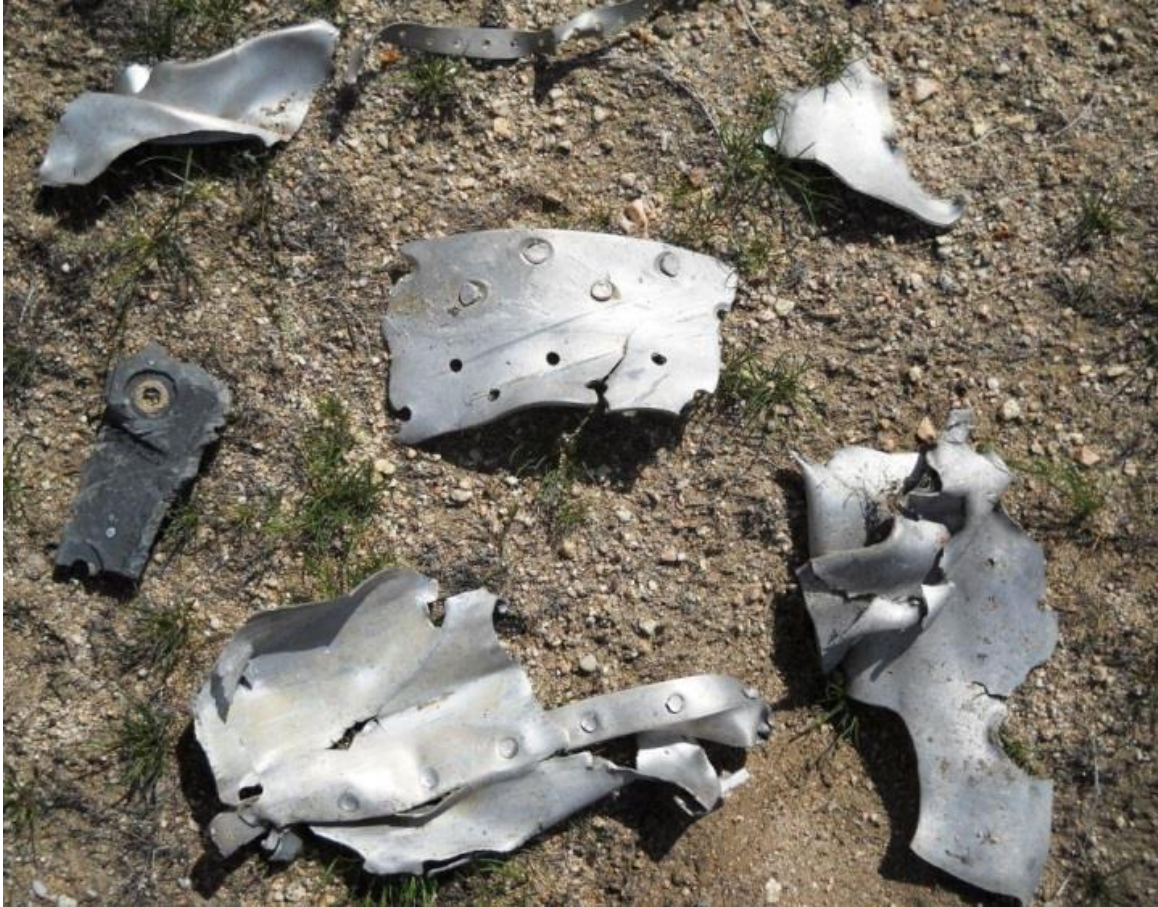
I spent too little precious time examining the crash impact site before I rushed to explore further in search of the second impact point which I never found. I did find aircraft parts dispersed over a wide area due to the high speed impact. The second major impact point remains undiscovered for now. It is out there somewhere in the vast Mojave.

Parts discovered in the debris field
